# BELZONA BONDS NEW BRACKETS TO TANK ROOF

ID: 7866

Water sprinkling and foaming systems on top of oil tanks.

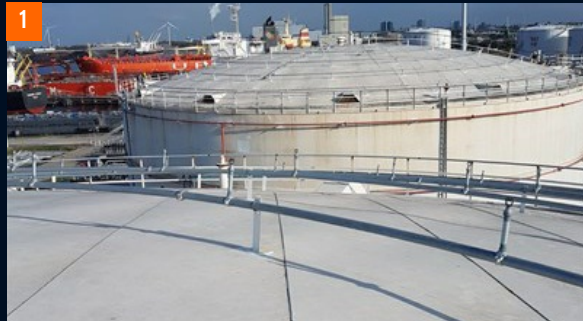
- 1- Overview of the tank roof
- 2- Final application
- 3- Zoom on a cold bonded bracket

For each tank, the substrate was prepared with a dust free blasting system in order to achieve the right surface roughness without generating dust and potential fire hazards near the oil. Then, the brackets were bonded using Belzona 1111. Over 1000 brackets/support were bonded over 7-8 different storage tanks. 8 brackets were bonded on the side of a few tanks, the remaining brackets were bonded on the top of the tanks. The vertical brackets were help in place using magnets and vice mechanisms, while the brackets on the roof were bonded without additional weight or pressure during the curing process.
