# 1000/700 ALLEN GWYNNE PUMP PROTECTED WITH BELZONA

ID: 787

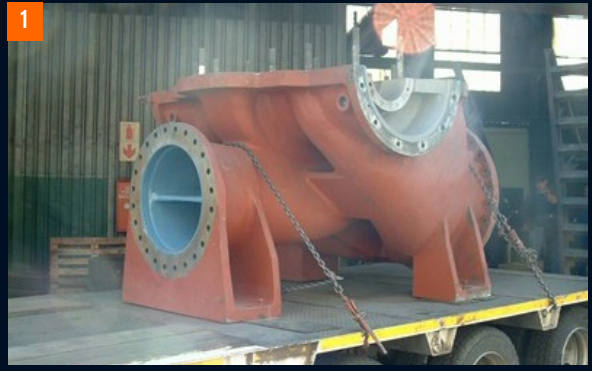
1. Pump being delivered to OEM after coating.
2. Pump internals
3. 9 ton bottom Section
4. Pump suction

Pump required coating to reduce corrosion and improve efficiency.

40 Kg of Belzona® 1341 were applied to this pump. This water authority has standardized on Belzona® 1341 for all their water pumps.
