# BELZONA COLD BONDING SYSTEM FOR WATER SPRINKLER TANK

ID: 7905

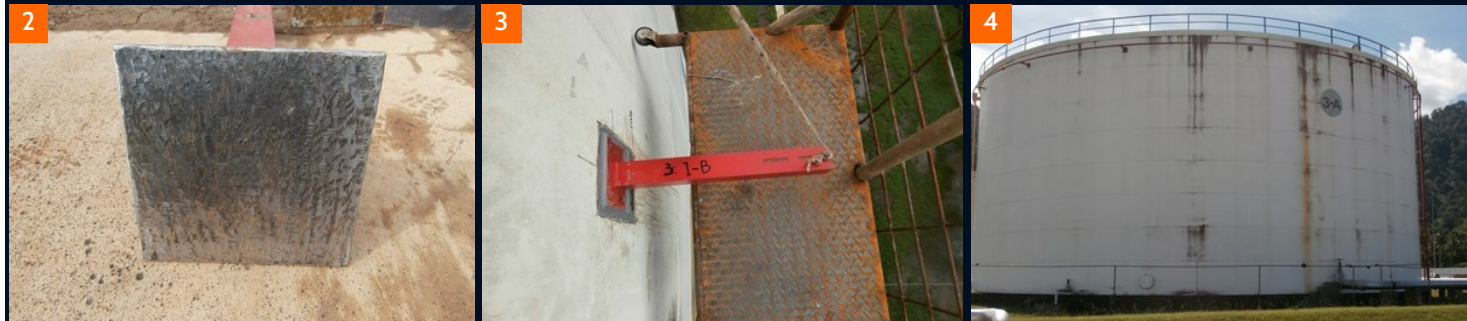
## PHOTOS

1. Crude Oil Storage Tanks
2. Surface preparation by Grinding
3. Bonded Bracket
4. Completed Application

Oil reservoirs are old reservoirs where there is no hydrants attached to the tank wall, therefore a cold connection method is needed to avoid the danger of fire when adding the design to the tank.

Customer required installation of a fire protection system without the use of hot work

The application was carried out in accordance with Belzona Know-How System Leaflet (TCC-6 and VPF-15).

1161 (Super UW Metal)
