# BELZONA BONDS FRAMEWORK TO OILRIG DECK

Support structure (sub frame) for Temporary Living Quarters on Oil Rig.

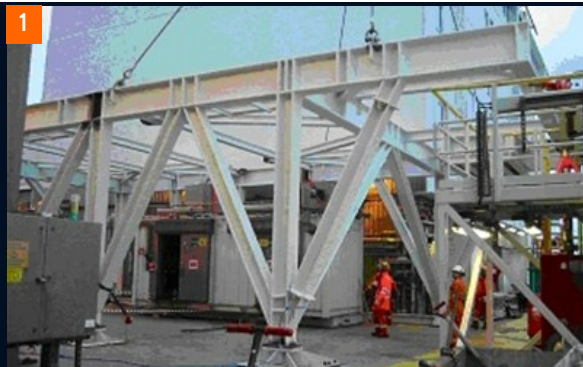
1. Lowering of sub frame into position and alignment.
2. Bonding application completed.
3. Accommodation Modules in position.

Due to the extended time after alignment/sealing to the bonding phase nitrogen was used to prevent flash rusting in the void to be filled with the Belzona® 5811. To combat the very cold conditions in the North Sea, January (0°C) heat blankets were used to allow the works to be completed.
