# BELZONA 1812 APPLIED INSIDE SMALL-DIAMETER PIPES

ID: 7926

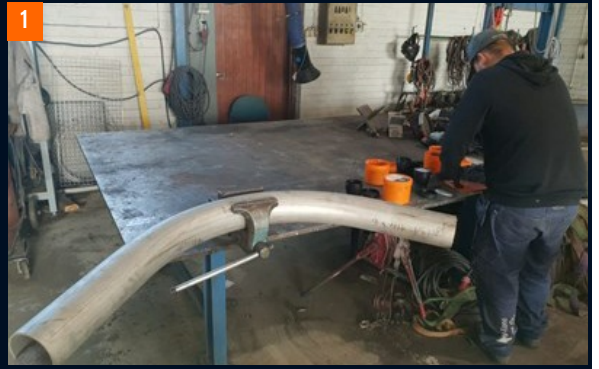
Hard abrasion from rock and mineral dust wore out long pipes with small orifice-diameters which led to a long downtime. Repairs and new installations were often required.

1. The pipe to be repaired
2. The application of Belzona 1812 underway
3. Application complete before dressing back

To be able to apply Belzona 1812 inside a 2-meter long and 100mm diameter pipe bend, the contractor used a similar punch-tool as they use when applying a rubber surface into pipes. The punch-tool was pulled through the pipe with a wire and Belzona 1812 was pressed onto the sides of the pipe. Using different sizes, a sufficient thickness has been achieved. The application was completed in accordance with a modified version of Belzona Know-How System Leaflet SHM-08.
