# BELZONA REPAIRS 6 HEAT EXCHANGERS

ID: 7933

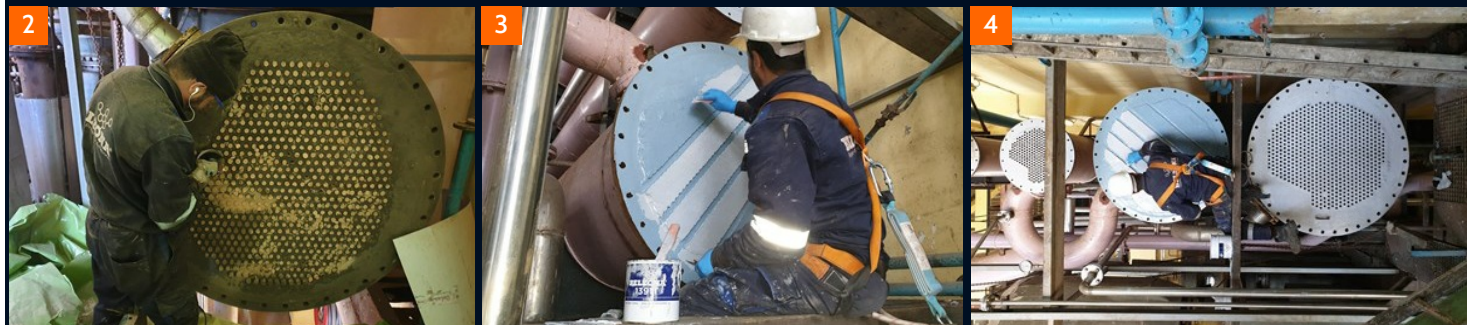
12 tube sheets suffering from corrosion and chemical attack were exposed to elevated temperatures (up to 200°C - Dry Heat) when in service, therefore requiring a full tube sheet rebuild and protection.

Heat exchangers within the food industry were corroded and suffered from severe chemical attack.

1. Initial Damaged Surface of the Tube Sheet.
2. Surface of the Tube Sheet once Rebuilt,
3. Surface of the Tube Sheet once Coated with Belzona 1391T,
4. Final finish of several Tube Sheets.

The application was carried out in accordance with Belzona System Leaflet HEX-01. The substrate was grit blasted and cleaned using Belzona 9111. All tubes on the tube sheet were corked - using over 6000 corks. The surface of each tube sheet was rebuilt back to its original profile using Belzona 1511, a conical grinder was used to chamfer the product around each tube. Once rebuilt the tube sheet was coated using Belzona 1391T to prevent corrosion and chemical attack from the Hexane gas. Belzona 1391T is perfect for higher temperature applications such as these where the operating temperature was 120°C (up to 200°C - Dry Heat). Once the tube sheet coated the corks were drilled out and the tube sheet cleaned using compressed air.

The only alternative for this piece of equipment would have been to replace the whole of the heat exchanger, replacement was therefore not an option. Belzona was able to not only rebuild the original profile but also prevent future corrosion and protect against chemical attack. 50KG of Belzona 1511 and 21KG of belzona 1391T were used for this project.
