# BELZONA PROVIDES SEA WATER FILTER PROTECTION

ID: 794

Sea Water Filter System on offshore oil production platform

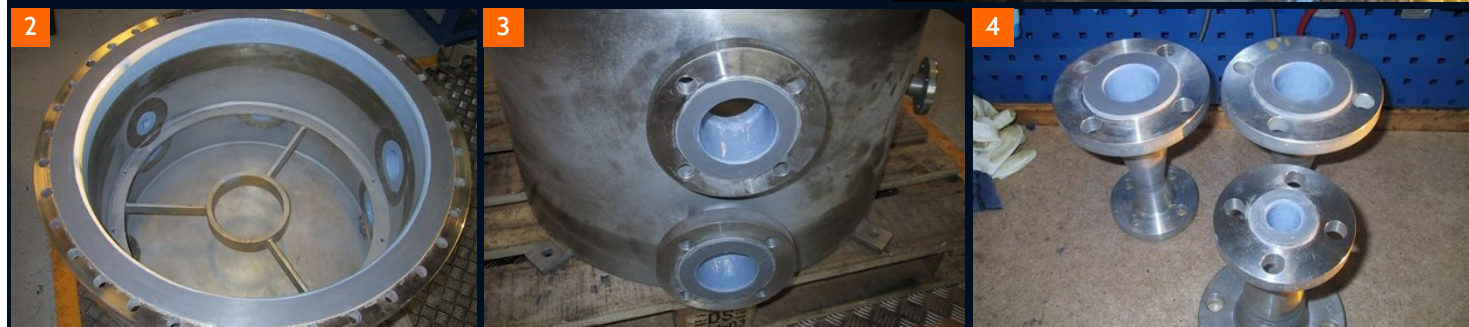
Conventional coatings were failing around the sealing faces and nozzle areas.

1. Main body of filter
2. Vertical view showing protected flange faces
3. Exit nozzle coating
4. Individual small bore nozzle coating

The application was carried out using a combination of Belzona Know-How System Leaflets TCC-3 and VPF-13.

Belzona 1111 (Super Metal)

Belzona 1321 (Ceramic S-Metal)
