# BELZONA ALTERS YACHT WINDOW FRAMES WITH EASE

ID: 7949

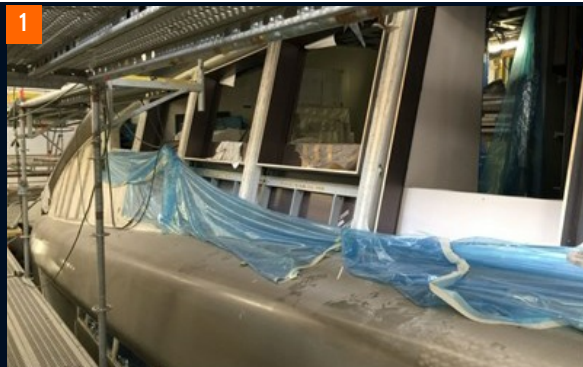
1. General view of window frames
2. Surface being prepared for application
3. Belzona applied with formers in place
4. Completed application

The application was carried out in accordance with a modified version of Belzona System Leaflet GSS-9. Belzona 1121 was used to build up the thickness of the window frames by 1 - 1.5 cm. A forming technique was used to ensure precise tolerances. Belzona 9411 (Release Agent) was applied to the formers so that they could be easily removed after the Belzona 1121 had cured.
