# BELZONA STAIRWAY TO HEAVEN

ID: 7962

## PROBLEM

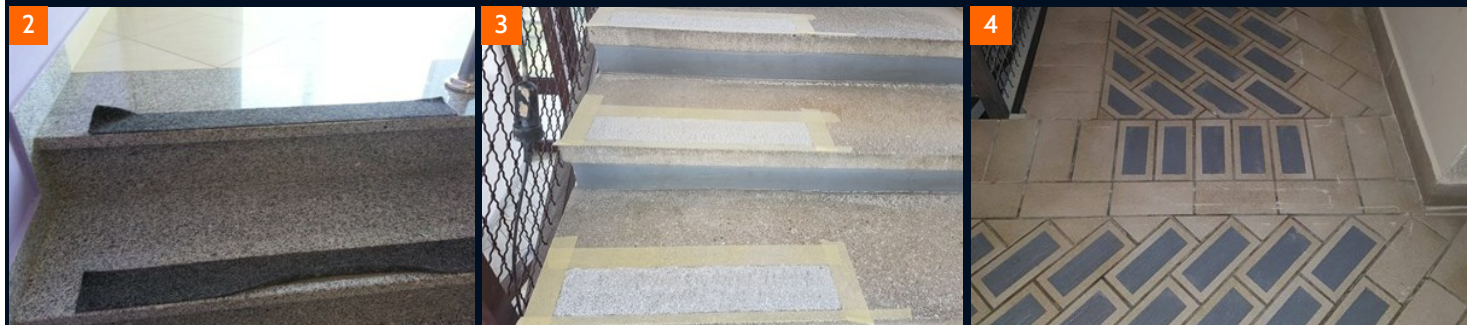
The application was a four story building with 32 flats and the stairway wasn't heated as it was located at the end of the building. The Ceramic tiles in the stairway got very slippery and in winter the water on the floor often freeze, creating a trip hazard.

The customer had previously installed several types of cheap adhesive tapes which all lasted a very short time and didn't perform well. Since this was an indoor application and the distributor knew that the price would be an issue. One coat of Belzona 5231 with Belzona 9221 (Sure-foot Aggregate) incorporated was recommended. 2 packages of Belzona 5231 (Dark Grey, 4 liters each) and 5 packages of Belzona 9221 (2 kg each) were used.

1. Block at flat of where the application was taking place
2. Previous cheap adhesive tape solution
3. Belzona 5321 being applied
4. Finished application

This application was carried out in accordance with Belzona Know - How system Leaflet FPA - 8. There were 99 stairs (120 cm x 35 cm each) and a hallway on each floor. Anti-slip strips (105 cm x 10 cm) on each stair and in the hallway were applied. The application was carried out in 2 phases in two phases to allow the residents to use the stairway during application. For each phase, the surface was marked with masking tape, then the ceramic tiles were abraded with a rotary grinder. After that Belzona 5321 was hand applied with brushes, incorporating Sure-foot Aggregate with small rollers.
