# BELZONA COATS YACHT'S WATER JET SYSTEM

Coating of the water jet propulsion system of a newly constructed yacht.

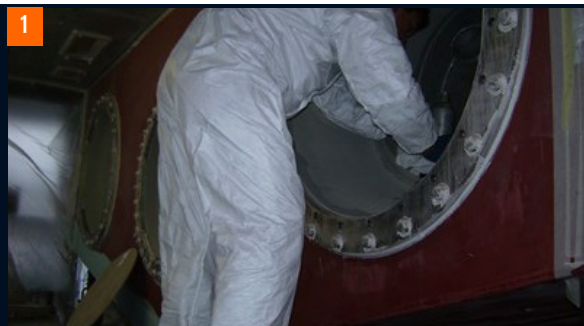
1. Water jets during the cleaning phase
2. View after the first coat of Belzona 1341
3. View after the second coat of Belzona 1341
4. Finished application

Application was carried out in accordance with Belzona Know-How system leaflet SOS-02. The substrate was blasted to SA 2.5 cleanliness and cleaned with acetone. 2 coats of Belzona 1341 (Supermetalgilde) were then hand applied to coat the system.
