# LANDING CRAFT WATER JET NOZZLES PROTECTED BY BELZONA

ID: 7995

Stainless Steel water jet nozzles on a naval landing craft in dry dock.

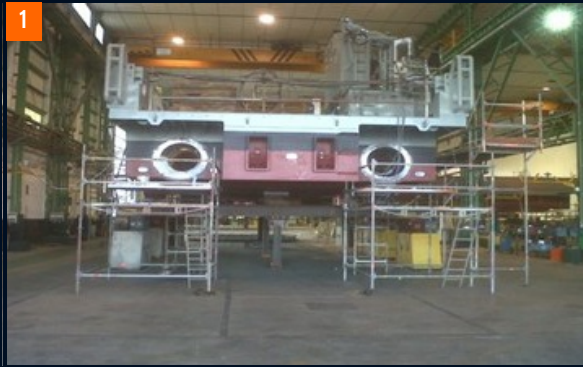
1. View of the vessel hull
2. Surface prepared, and Belzona 1321 (Ceramic S-Metal) applied
3. Belzona 1812 (Ceramic Carbide FP) applied
4. Completed Application
