# ANTI-CORROSION PROTECTION BY BELZONA

ID: 8052

Anti-corrosion protection of a sulfuric acid tank together with the existing infrastructure.

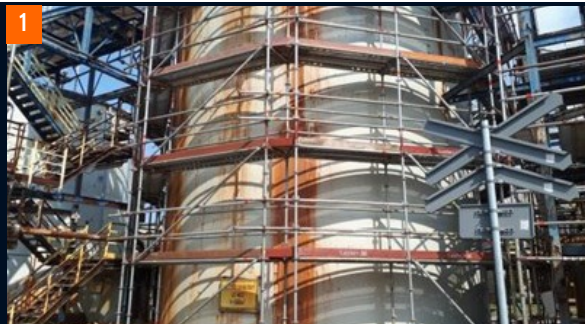
Degradation of the existing anti-corrosion system and rapidly progressing corrosion of steel. Exposure to UV rays and atmospheric precipitation. A very aggressive chemical industry environment and fumes of sulfuric acid. Periodic pouring with sulfuric acid of 97% concentration and 40C temperature.

1. Corrosion of the sulfuric acid tank
2. Application of the chemical resistant composite Belzona 5811
3. Application of the topcoat layer of Belzona 5111
4. Application Complete
