# MODERNISATION OF A CONCENTRATION TANK AREA WITH BELZONA

ID: 8059

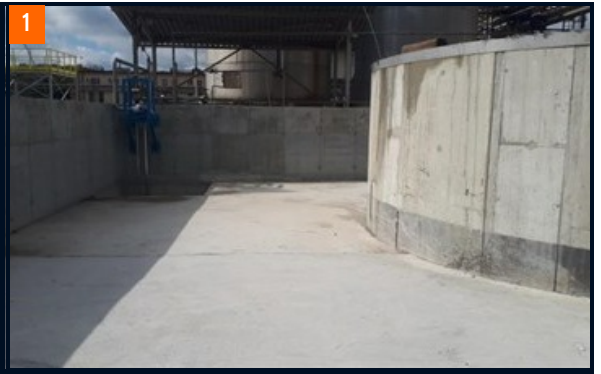
1. Area of application Picture
2. Tiling area.
3. Grouting of tiling using Belzona 4181
4. Completed Application using Belzona 4181
