# BELZONA COLD REPAIR TO A LEAKING PIPE JOINT

ID: 8066

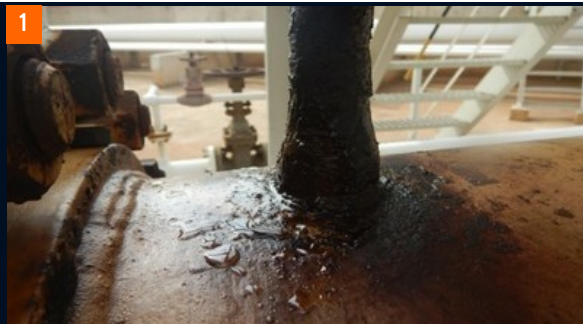
A 1" pipe branching from the 14" main line has a crack and a leak at the joint area. As the line contains flammable fluids hot work is not an option.

1. Defect area
2. Surface Preparation Complete
3. Application in progress
4. Completed repair
