# BELZONA REPAIRS AND PROTECTS OIL/GAS/WATER SEPARATOR

ID: 8083

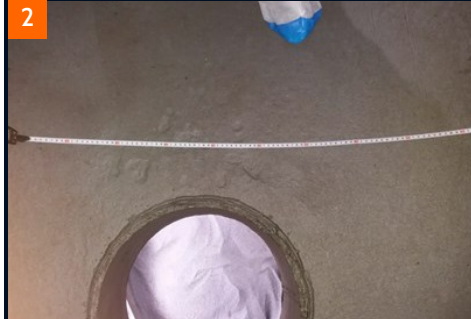
1. General view inside separator after grit blasting
2. Corrosion in the wall
3. Repair of corrosion areas
4. Completed application

The application was carried out in accordance with Belzona Know-How System Leaflets TCC-5. The separator surface was cleaned, degreased and grit blasted. Following the grit blasting, stripe coating of all internal weld areas and outer edges were completed and areas of severe corrosion and pitting were identified and repaired using Belzona 1111 Super Metal. A two coat system of Belzona 5892 was applied to protect the separator from further corrosion. The lower section of the first separator stage was then coated with two layers of Belzona 1381 for added erosion-corrosion resistance.

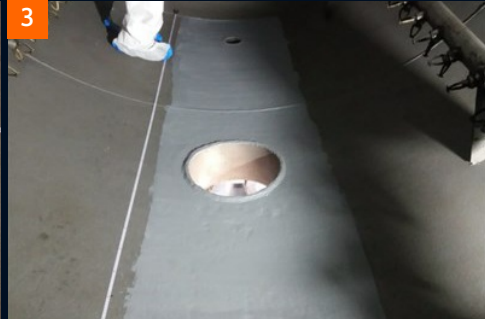
General pitting corrosion on the wall and severe erosion-corrosion in the lower section of separator due to the presence of sour gas.
