# BELZONA PROVIDES COST EFFECTIVE MAINTENANCE OF OIL CENTRIFUGES

ID: 81

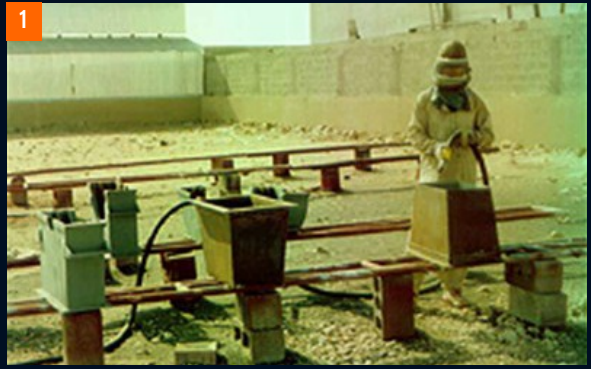
1. Centrifuge components being grit blasted.
2. Some of the components after coating with Belzona 1321.
3. The scroll from a centrifuge.

The application is carried out in accordance with Belzona Know-How Leaflet TCC-3.

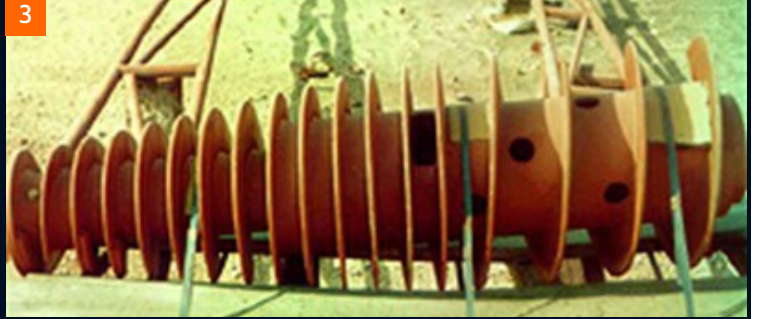
The units revolve at 3500rpm. and the sand particles cause severe erosion requiring the units to be completely overhauled on an annual basis.
