# BELZONA PROTECTS HYDRAULICS ON WORLDS FIRST TIV

ID: 8139

Hydraulic pipe fittings.

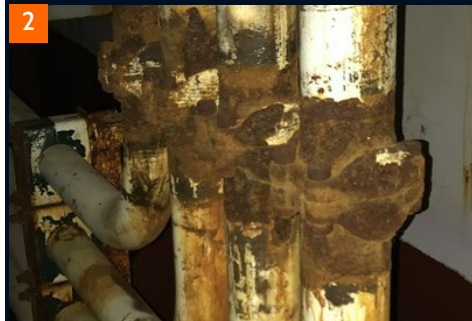
1. Turbine Installation Vessel in action
2. 78mm diameter hydraulic pipework
3. First coat of Belzona 3412 in progress
4. Peelable protection completed

The application was carried out in accordance with Belzona System Leaflet GSS-11. The Belzona 8411 was applied to release the areas of the fittings, before coating Belzona 3412 over the area and extending 125mm onto each side of the pipework.
