# BELZONA LINES AN AIR RECEIVER

ID: 8142

## PROBLEM

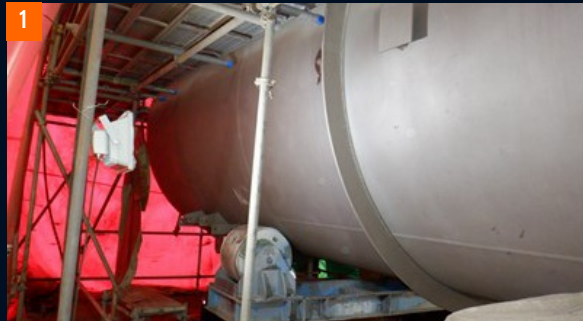
1 General View of Vessel

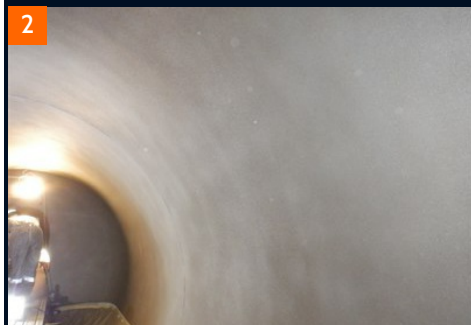
2 Vessel after grit blasting

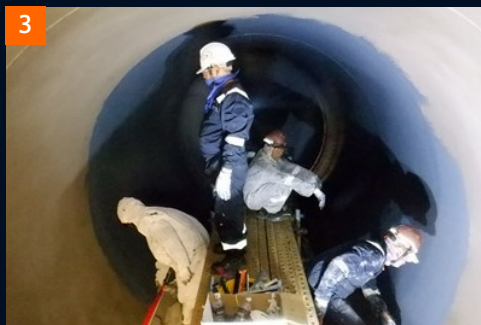
3 Application underway

The application was carried out using a combination of standard paint brushes, the Belzona applicator and the Belzona Squeegee brush developed in the Belzona Asia pacific facility in Thailand

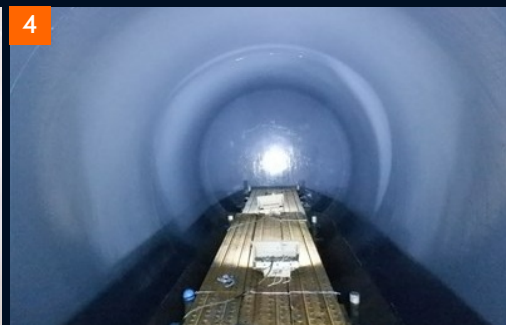
4 Application completed
