# BELZONA REPAIRS LIGHT GAUGE CONVEYOR BELT

ID: 8147

## PROBLEM

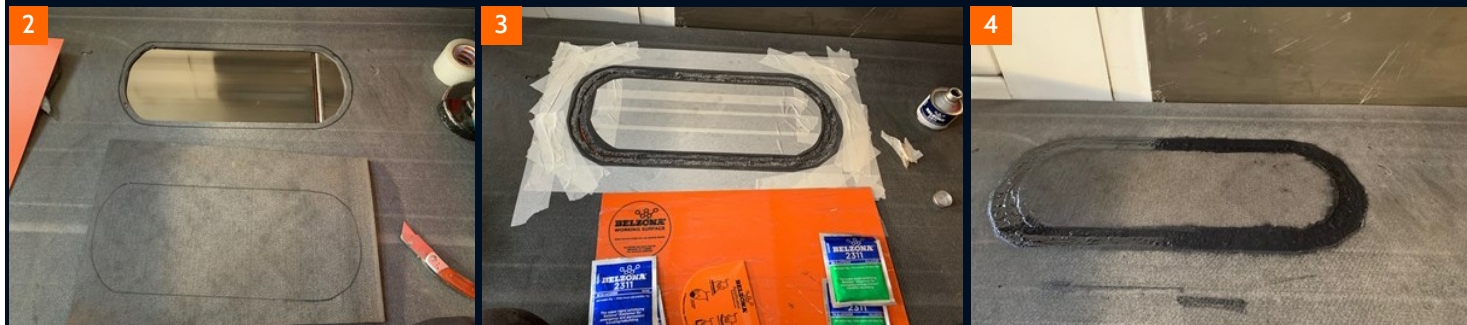
## PHOTOS

The large distribution center operate around 300 belts for conveying stock, mainly in plastic tote boxes. The boxes can approach 200Kg and fall through chutes hitting the moving belts. The belts are suffering damage and, at present, the client have no way of repairing the belts, forcing exchange at a cost of around £3,000 per belt.

1. Repair scenario (Power tool shown for scale)
2. Patch cut from spare belt
3. Masked area and repair being completed using 2311
4. Full repair completed. Repair time around 40 minutes

Application was carried out in accordance with a modified version of Belzona System Leaflet SHM-1. Following successful trial applications, the Belzona solution that was selected involved the cutting out of the damaged area. A patch was then created using a spare piece of conveyor belt. The new piece of belt was then bonded in place using Belzona 2311 (SR Elastomer).
