# CHEMICAL RESISTANT BELZONA LINING APPLIED TO INTERIOR OF MIXER DRUM

ID: 8167

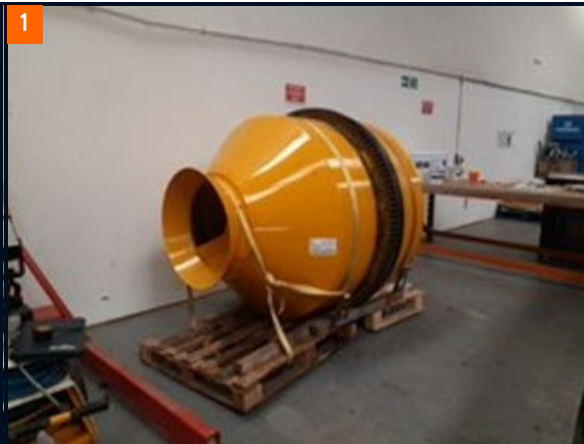
1. Mixer drum delivered to workshop
2. Internal substrate prepared
3. Voids between blades filled
4. Completed lining
