# BELZONA STRUCTURAL REFURBISHMENT OFFSHORE

Water-proofing of control rooms for offshore oil-gas separation plants

Oil Production Platform in Saudi Arabia

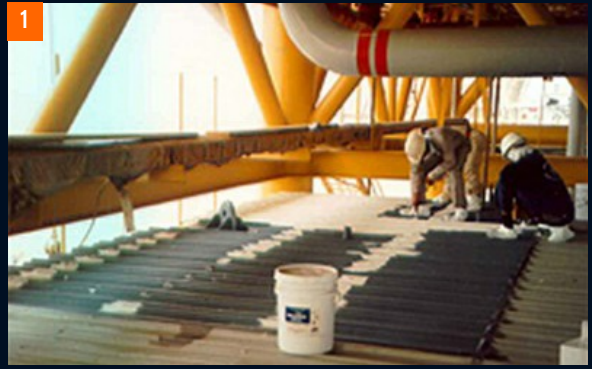
1. Applying the first coat of Belzona 3111.
2. First panel done.
3. The completed structure protected from the rigours of the offshore environment.

The application was carried out in accordance with Belzona Know-How Leaflets RPA-1 and TCC-1.
