# BELZONA PROVIDES CORROSION PROTECTION FOR HEAT EXCHANGER TUBE SHEETS

ID: 8231

Heat exchanger tube sheet in a chemical plant.

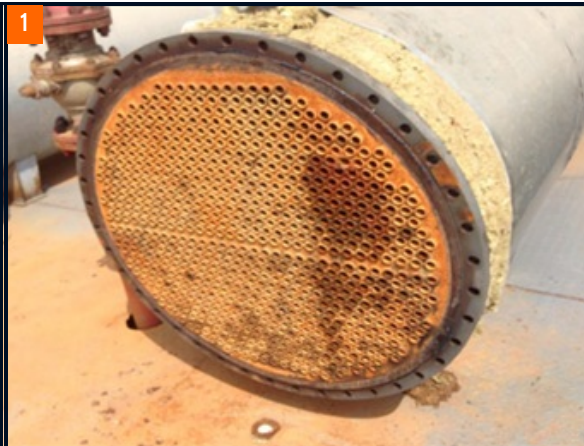
The tube sheet needs protection from high-temperature corrosion, chemical corrosion and bimetal corrosion to prevent further metal loss. Otherwise, it will cause leakage, decrease in efficiency and pollution.

1. Heat exchanger tube sheet before grit blasting 2. Grit blasted heat exchanger tube sheet 3. Repaired pitted areas using Belzona 1111

Application carried out in accordance with Belzona Know-How System Leaflet HEX-1 and HEX-3.

Belzona 1111 (Super-Metal)  
Belzona 1391 (Ceramic-HT)
