# BELZONA PROTECTS SEWAGE SEPARATOR OF A NEW PROJECT

ID: 8254

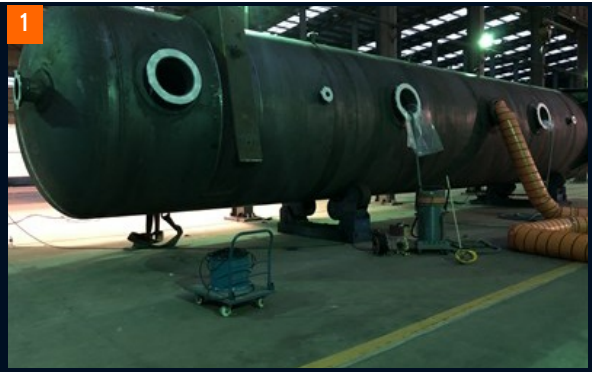
1. The process vessel ready for application
2. Spray applying the first layer of Belzona 5892
3. Spray applying the second layer of Belzona 5892
4. Application complete

Application carried out in accordance with Belzona Know-How System Leaflet TCC-5. Belzona 5892 was spray applied on main areas and brush applied on small areas where spraying is inconvenient.
