# BELZONA PROTECTS NEW-BUILD SEPARATOR FOR NATURAL GAS PLANT

ID: 8256

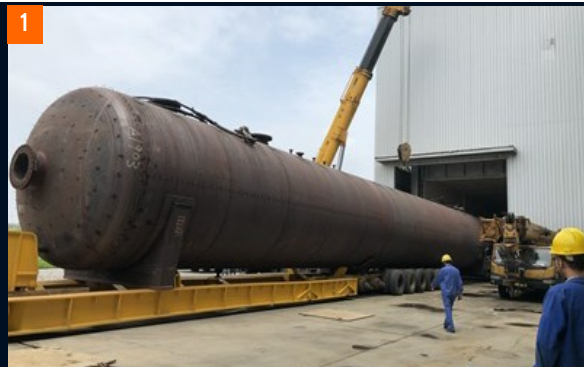
1. Exterior of the separator
2. Pre-coating Belzona 1391T
3. Spray applying Belzona 1391S
4. Application complete
