# BELZONA SUPERWRAP II PROTECTS PIPELINES FOR CHEMICAL PLANT

ID: 8258

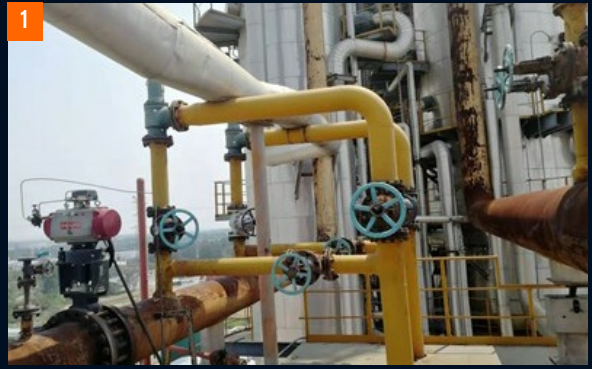
Corrosion and thinning of the auxiliary pipeline of the catalytic safety valve have affected the safe operation of the asset. To ensure the safe operation of the equipment and the safety of staff and property, the thinning areas of the pipeline are repaired and reinforced with Belzona SuperWrap technology.

Four DN150 safety valve auxiliary pipelines, designed for transferring oil, gas and water. The operating temperature is up to 150 °C, with a pressure of 0.3MPa. The initial wall thickness is 4.5mm, and the current regional thickness is 1.8mm. It is necessary to repair and reinforce the pipelines with reinforcing sheets. The length of each repair will be about 2 metres.

1. In-site conditions
2. Wrapping application in progress
3. Application of release film
4. Application complete
