# BELZONA 5831 PROTECTS WET SURFACE OF STEEL PIPELINES.

ID: 8276

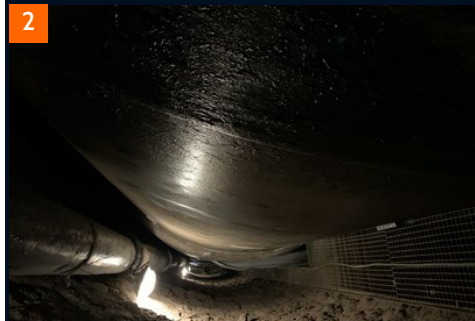
3 steel pipelines suffer from outside constant corrosion due to the moisty environment, so the customer needed to protect them. Space around of pipelines is not possible to make dry and it is not possible to use some conventional coats (also temperature of 5°C is a problem). It is necessary to use an environmental moisture-tolerant barrier coating.

1. Hydroelectric power plant
2. Wet surface of the steel pipeline in concrete tunnel
3. First layer done
4. Second layer of Belzona 5831

The application was carried out in accordance with Belzona Know-How System Leaflet VPF-2 for applying corrosion resistant coatings. The surface was abrasive blasted to prepare the area and Belzona 5831 (ST-Barrier) was applied directly onto the prepared surface with a spatula in a two coat system
