# TUBE SHEET ENGINE COOLING EXCHANGER PROTECTION WITH BELZONA

ID: 8282

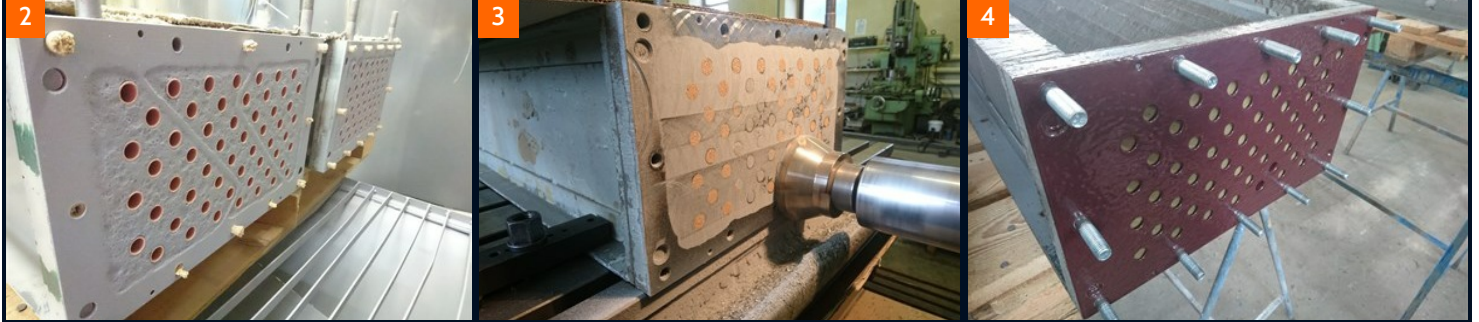
These strong acids even if they are diluted cause big corrosion.

1. Strong acids even if they are diluted cause big corrosion
2. The substrate was grit blasted and cleaned with Belzona 9111
3. Tube sheets are levelled on the milling machine
4. The application was then protected by 2 coats of Belzona 4311

The application was carried out in accordance with Belzona System Leaflet HEX-01. The substrate was grit blasted and cleaned with Belzona 9111. Then all the holes on tube sheets were plugged with corks. The corks were then cut at the tube level and Belzona 1111 (super metal) was used to rebuild the substrate. Tube sheets are levelled on the milling machine after that. The application was then protected by 2 coats of Belzona 4311 (magma CR1). The corks are taken off with a drill. The tubes were then cleaned with compressed air.

This customer needed some supplier, which is able to make these repairs in short and guaranteed time also in perfect quality with high resistant coating. After the reassembling they required the pressure test with 8 bars water. Because Belzona 4311 (magma CR1) needs for completion of the molecular reaction with full chemical resistance 7 days in 20°C (but customer wants to get back these exchanger in 5 days), we had to use force curing 80°C in 4 hours.
