# BELZONA PROVIDES A GRIP SYSTEM FOR MACHINE PLINTHS

ID: 8358

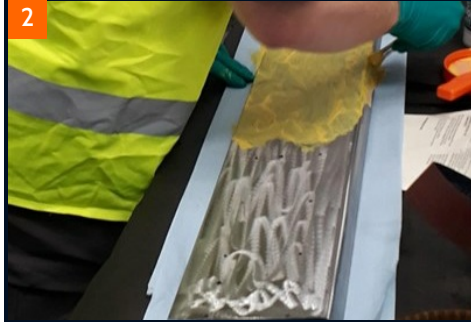
The elevated plinths used by the workforce to gain access and operate machinery in a large factory had plates fitted with a low-slip coating. This appeared to have been applied too thick and the aggregate was very deep in the coating, leaving little protusion and therefore low-grip.

1. Plates in position with original coatings
2. Application of Belzona 4411 to blasted and ground steel substrate
3. Training taking place
4. Finished plate ready for installation
