# BELZONA 5721 - LEADING EDGE PROTECTION FOR COLD WEATHER BLADES

ID: 8398

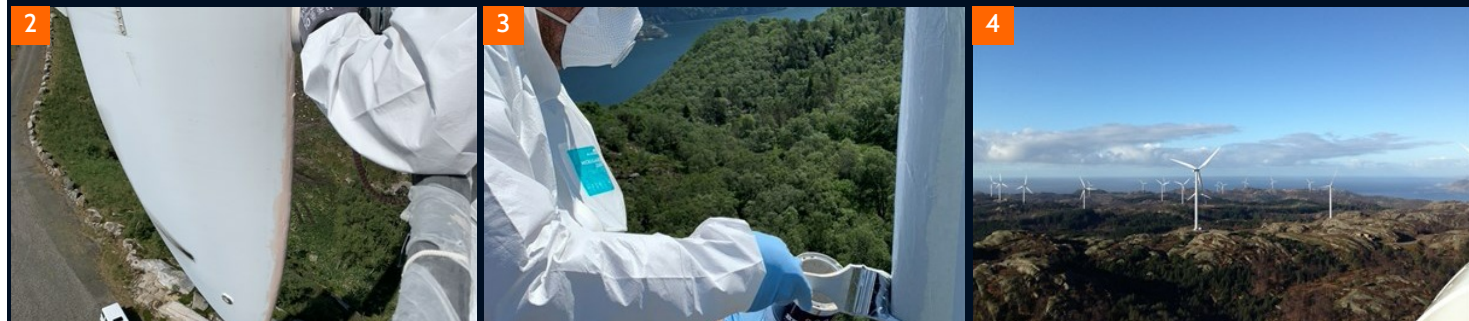
## PHOTOS

The asset had suffered from Erosion on the Wind turbine blades leading edges. This erosion, over time, can lead to a drop in the aerodynamics which leads to a reduction in the turbine energy output. This can account for anything from 5-20% loss in asset efficiency annually. Because of the cooler climate, traditional LEP coatings would have struggled to cure in ambient conditions.

1. Product Training - Kit
2. Surface Preparation
3. Application in Progress
4. Norwegian Wind farm

The application was carried out in accordance with a modified version of Belzona Know-How System Leaflet FBC-1. The blades were coated on the turbine at the operation site. The pitting and loss of surface on the leading edge was resurfaced with a filler product and rebuilt to dimensions. The surface area was sanded down with a mechanical sander and cleaned with a rag and non-residual solvent cleaner. One coat of Belzona 5721 at 20 mils (508µm) was applied.
