# ROLLER DOOR ENTRANCE REPAIR USING BELZONA

ID: 8436

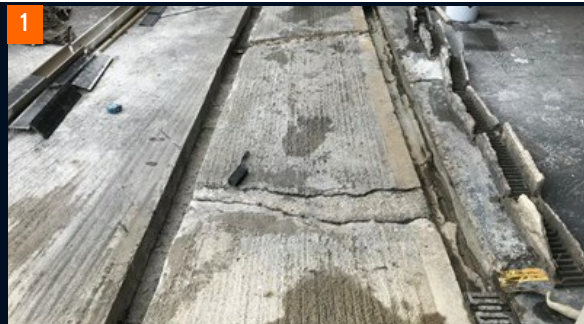
A concrete entrance had been compromised by years of wear from fork lift traffic running over a small concrete entrance pad which had suffered cyclic freeze/thaw in the winter, heavy rain and other erosive forces. The existing concrete had become compromised to a limit where it had become a safety hazard to run industrial traffic over the area

1. Prior to repairs 2. Finished application  
3. Aco drains installed 4. Aco drains installed

The concrete was prepared as per the Belzona 4131 IFU and the application was carried out in accordance with Belzona System leaflet FPA-1. The Aco drain gulleys were dug out and the Aco drains installed. Belzona 4911 was mixed and applied to specification as per the Belzona 4131 IFU. Belzona 4131 was mixed and applied according to the Belzona 4131 IFU. The area was left to cure for the recommended time according to ambient temperatures.
