# BELZONA KEEPS FLOOR CLEAN AND SAFE IN THE FOOD INDUSTRY

ID: 8445

Concrete floor in warehouse of food factory

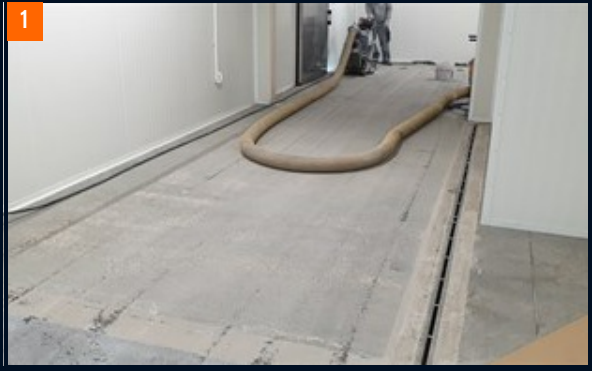
1. Surface preparation
2. Application first layer of Belzona 5231
3. Application second layer of Belzona 5231
4. Application complete

Preparation was completed using large floor grit blaster and vacuums, followed by the application of the Belzona 5231 in accordance with Belzona Know-How System Leaflet FPA-3.
