# DAMAGED CONVEYOR BELT RESCUED BY BELZONA.

ID: 8473

Scored conveyor belt on a screen separator

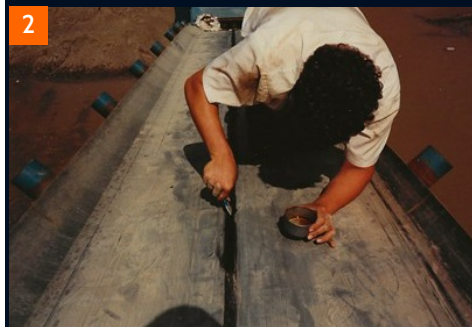
A sharp object had caught in the screen section and gouged the almost-new belt down to the reinforcing cord. Having the interior of the belt constantly exposed to the outdoor wet environment would shorten its life. The only other alternative was a costly replacement.

1. Undercutting and roughening the repair area
2. Conditioning with Belzona 2911
3. Applying Belzona 2111 to fill the gouge.
4. A piece, cut from the retired belt showing Belzona 2111 fully intact

The belt was cleaned of dirt and sand. The gouged area was undercut using a utility knife and roughened using a hand roughing brush. Then it was cleaned, using a rag LIGHTLY moistened with Belzona 9111. Belzona 2911 was applied using a cut-back brush. Belzona 2111 was mixed and applied to fill the gouge.
