# BELZONA PROTECTS NEW SEAWATER FILTERS FOR DESALINATION

ID: 8484

As part of the construction of a new Reverse Osmosis Desalination plant, 14 large media filters have been manufactured and are in need of internal protection.

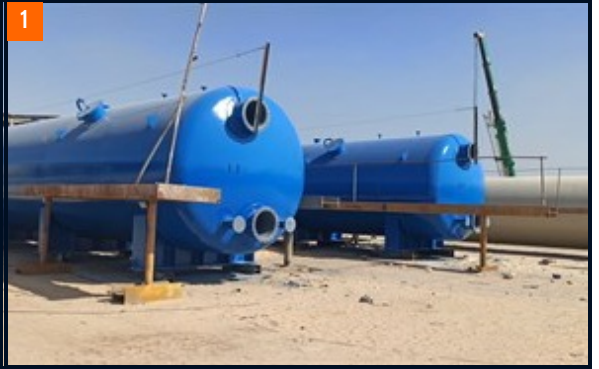
1. View of the filters from the outside
2. Internal surface after surface preparation
3. Internal surface after first coat
4. Completed application
