# BELZONA PREVENTS SLIPS & TRIPS BY USING A POSITIVE GRIP COATING SYSTEM

ID: 8534

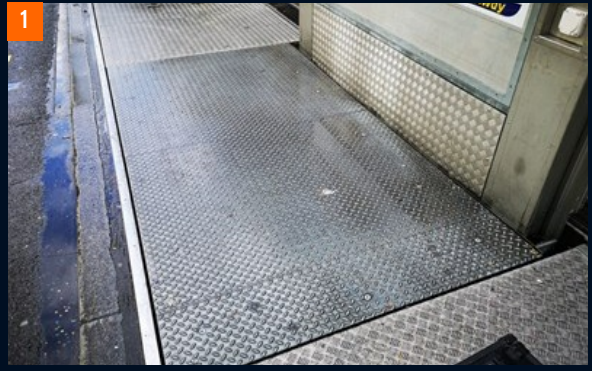
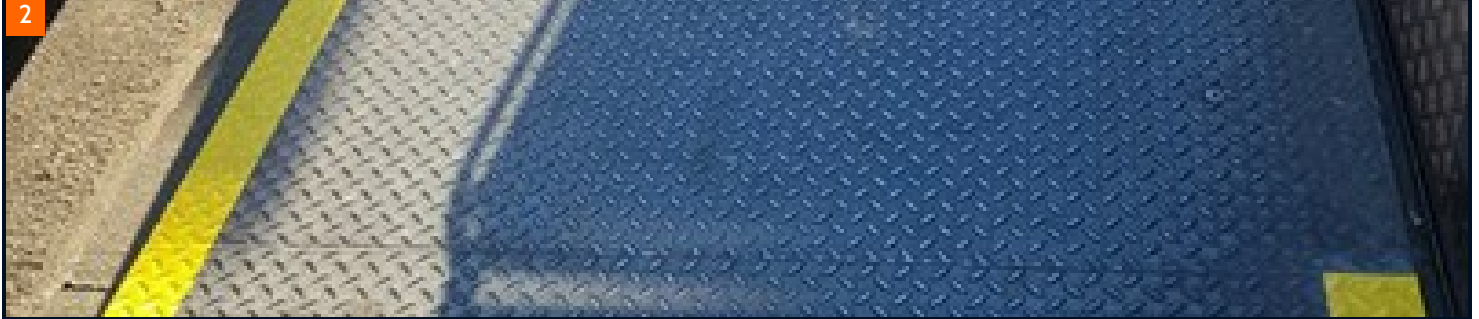
## PHOTOS

The customer wanted a coating that was both visible and tangible, as the loading ramp can be raised to 1.15m.

Aluminium checker plate loading ramp.

- 1). Original condition without Belzona
- 2). Security coating and marking area with Belzona 4411

The surface was initially prepared using appropriate power tools. It was then coated using Belzona 4411, followed by the incorporation of Granogrip prior to being over coated with a second layer of Belzona 4411.

Belzona 4411 not only provided a visually striking coating that would raise visual awareness but thanks to the incorporation of aggregate fillers also provided a physically grippy surface making employees aware of the risk area they are operating within.
