# BELZONA TAKES THE FLOOR

ID: 8538

An Aluminium production plant had extended their production area, installing new flooring of 1750 sqm.

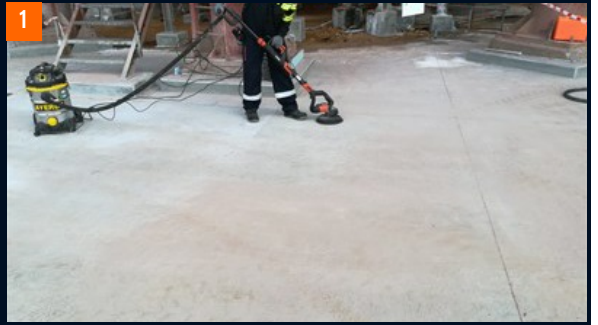
1. Preparation of concrete floor
2. Application of Belzona 4981
3. Belzona 5892 applied to plinths
4. Completed Application

The application was carried out in accordance with a modified version Belzona Know-How System Leaflet FPA-3. After allowing the concrete to dry for 28 days, the concrete floor was prepared by vacuum cleaning to remove dust and loose particles, leaving a clean, dry and firm substrate. Belzona 4181 was applied to the area to prevent outgassing and provide excellent adhesion to the concrete. Belzona 5892 was then applied as a 2-coat system to protect the concrete from chemical spillage and provide a robust flooring surface for regular foot traffic.
