# BELZONA STRENGTHENS NOZZLES OF TEG FLASH TANKS ON OFFSHORE PLATFORM

ID: 8568

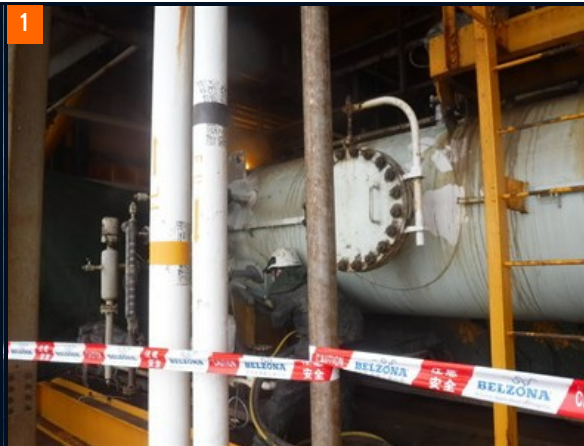
1. Surface preparation
2. Nozzles after blasting
3. Complete application of Belzona Superwrap II
4. View of nozzles after 3 years

The repairs were designed in accordance with ISO24817 standard. The application was completed by Belzona trained and validated installers in accordance with Belzona Know-How System Leaflet VPF-11. Belzona supervisor and the on-site representative supervised the whole process. The whole application involved 8 two-inch nozzles.

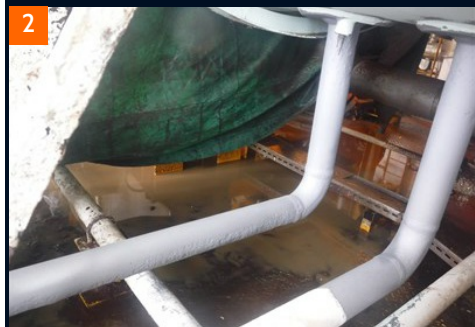
Due to the damage of the original insulation layer, nozzles of the TEG flash tank were corroded under the insulation layer (CUI). The nozzles had developed thin-wall defect and through-wall defect.

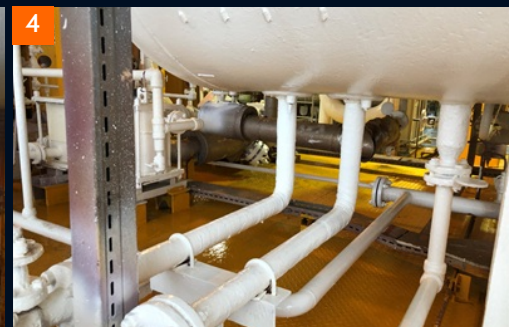
For welding, the whole TEG flash tanks need to be shut down and isolated, with thorough cleaning and water injection, which costs at least 15 days of downtime and affects the production. Welding in confined space may also cause hazards. Therefore, the customer has been looking for the solutions with no hot work required but also accepted by classification society. Meeting the standard of ISO24817 and ASME PCC-2, Belzona Superwrap II can repair the nozzles of pressure vessels on-site, with no downtime or hot work required. The application is still in good condition after 3 years.
