# BELZONA 5871 PROVIDES INNOVATIVE THERMAL INSULATION SOLUTION

ID: 8582

A newly fabricated, aerial oil dispersant vessel to be used in cold environments, offshore.

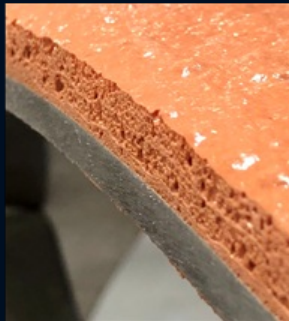
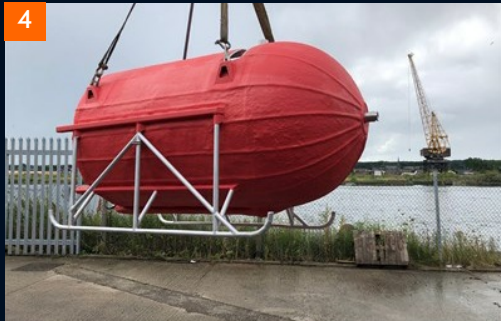
1. Fabricated aluminium vessel.
2. Blasted Vessel with trace heating positioned around vessel – close-up of surface preparation.
3. Three coats of Belzona 5871 completed. Close up of trace heating panel to show the thickness of coating.
4. Vessel coating completed with a Belzona 3211 system applied. Ready to be transported to the client.

Prior to coating the vessel was grit blasted to SA 2.5 with a minimum average profile of 75 microns, followed by the positioning of the trace heating elements. Three coats of Belzona 5871 were then spray applied at a wet film thickness of 1mm per coat. Due to the inherent expanding properties of the Belzona 5871, this amounted to a total DFT of >9mm. Belzona 3211 (Lagseal) incorporating a reinforcing sheet was then applied over the Belzona 5871 to provide additional UV protection and a degree of fire retardant.
