# BELZONA PROVIDES LEADING EDGE PROTECTION (LEP)

ID: 8583

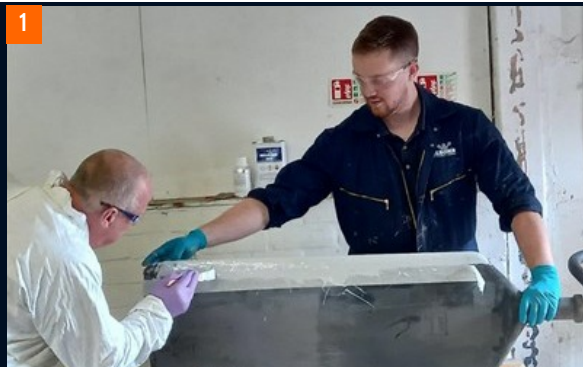
1. Training taking place
2. Blades awaiting preparation
3. Finished blades awaiting dispatch to site
4. Closer detail of finished LEP and full body protection coating

Training was given from the UK Sales Technical team to the contractors at their works. The blades were sanded to provide a key, then 2 x coats of 5811 were applied to the total surfaces of the fan blades. After curing, the 5811 was again abraded along on the leading edge, approx 80mm either side of the blade's leading edge to the length of the blade. 2 coats of 5721 was then applied to complete the protective application.

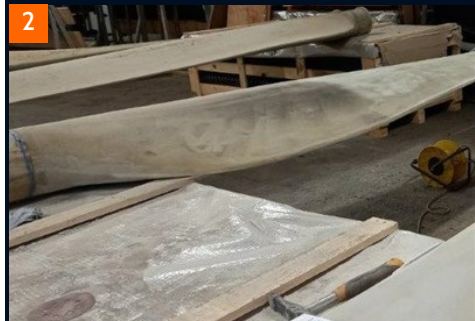
A cooling tower with 4 x 9mØ cells, each with 9 x 4.5m blades was to be refurbished, the main part of the works was to replace the blades. This was mainly due to wear and expected erosion leading to failure of the blades. Our client stepped in to offer a solution to keep the existing blades and coat them to protect the client's assets.
