# LED LIGHT FIXTURE BONDING WITH BELZONA ONTO A HOSPITAL ROOF

ID: 8591

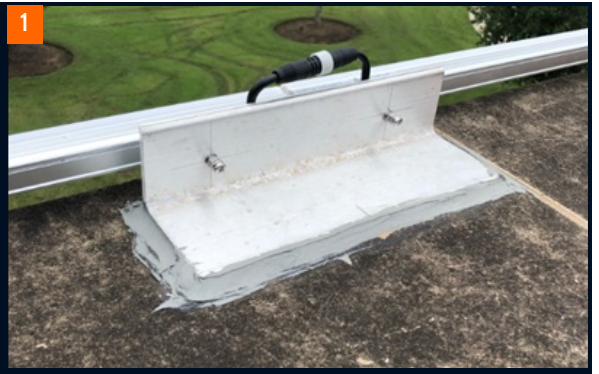
1. Close up of concrete bonding location
2. Overall Picture
3. Application onto metal coping.
4. View of fixture system

Aluminum angle brackets were to be bonded to the substrate in order to bolt on LED fixtures. The bottom of the brackets together with the substrate were prepared with a grinder to create a rough and clean profile. Belzona 4911 primer was used in all concrete locations. Belzona 1161 was applied to both the bracket bottom and substrate at about 1/16" inch thick. The bracket was then firmly pressed down to the substrate and exuded material was used to chamfer around the edges. Once in place, holes were drilled into the brackets and the LED fixtures were installed.
