# BELZONA PROVIDES ABRASION RESISTANCE TO CHUTES IN RECYCLING PLANT

ID: 8595

Aluminium Ingot Plant, UK

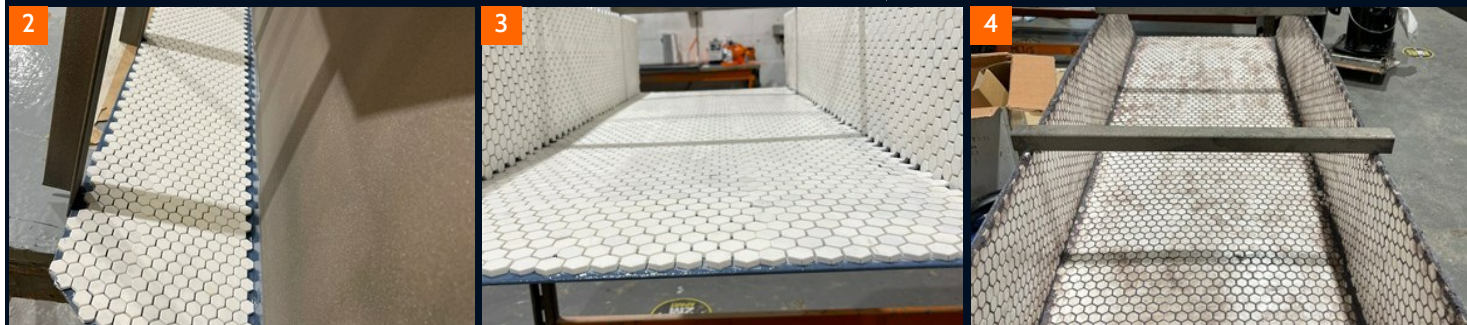
1. Newly fabricated chutes grit blasted and lined with Belzona 1321  
2. Belzona 9811 Alumina tiles adhered to the Belzona 1321  
3. Belzona 9811 Alumina tiles bonded in place using Belzona 1321  
4. Newly fabricated abrasion-resistant chutes ready for delivery to the customer

New steel chutes were fabricated and delivered to Belzona Wrexham workshop. The chutes were then grit blasted, cleaned and degreased in preparation for the Belzona application. A single coat of Belzona 1321 (Ceramic S-Metal) was then applied. A sheet of Belzona 9811 (Alumina Tiles) was then tenaciously bonded into the Belzona 1321 which is used as an adhesive. Once cured, Belzona 1812 (Ceramic Carbide FP) was used as a grout making the surface in between the hexagonal tiles as smooth as possible. This material ensures excellent adhesion between the tiles and on the edges / terminations. This also ensured there were no pick-up areas for the cans to get stuck on. The Belzona products were applied in accordance with the Belzona System Leaflet SHM\_07. Once completed, the new chutes were returned to the client to be put into service.
