# BELZONA WEATHERPROOFS INSULATED ROOFTOP DUCTING

ID: 861

Heated and cooled air roof top ducts.

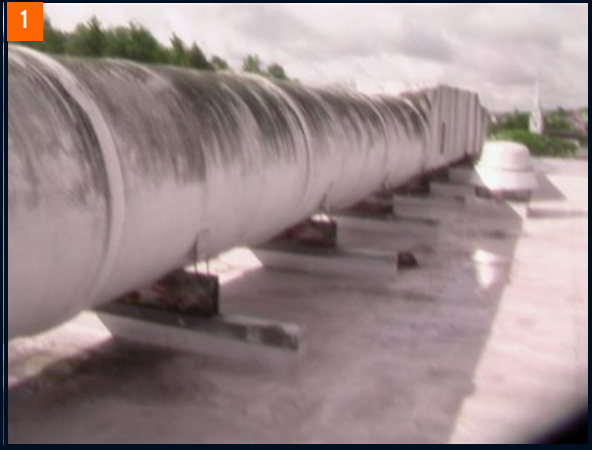
Original protection no longer water-tight. Insulation was wet and water was leaking into the building. CUI was feared.

1. Degraded insulation on ducts
2. Degraded insulation at building interface
3. Recoated and protected with Belzona
4. Summer 2007 still as good as new!
