# BELZONA STOPS A LEAK AND STRENGTHENS A PIPE.

ID: 8685

Circulation pipe on a sea vessel.

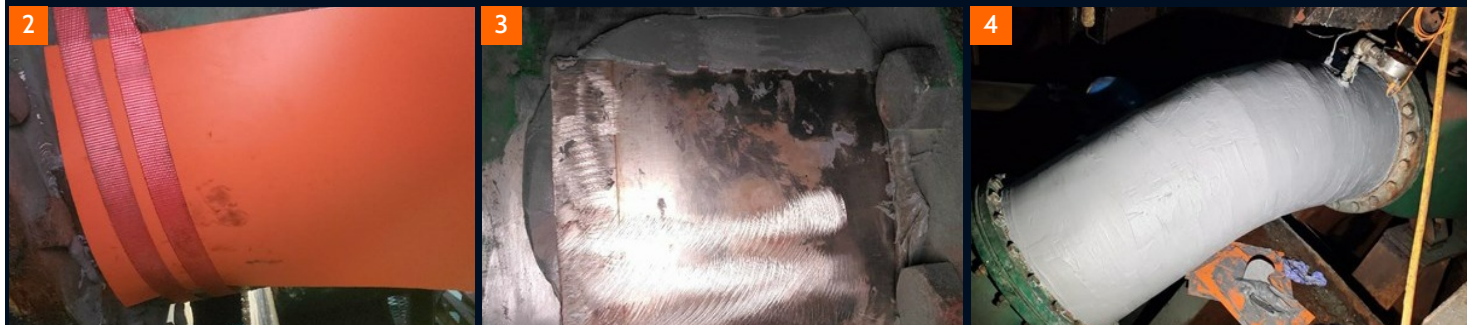
There was a fair-size hole and a large thin-wall area on the elbow of a 30" circulation pipe on a sea vessel. The hole was located where the pipe passed through a bulkhead at the very bottom of the vessel.

1. Close pictures of the hole.
2. The Belzona mixing board strapped in place.
3. Belzona 1212 and doubler plate.
4. Application complete.

The area around the hole was prepared with a grinder and Belzona 9611 was used for the initial plug. Belzona 1212 was then applied with a doubler plate over the Belzona 9611 since water was still present, and a Belzona mixing board was strapped into place over the Belzona 1212 and plate until it was hard. The remainder of the 30" elbow was prepared with a grinder and washed off with solvent. Belzona 1111 was then brushed into the surface, and loaded onto the Belzona 9341 reinforcement sheet and then wrapped around the pipe from one end to the other. A final layer of Belzona 1111 was applied over the wrap to finish the application.
