# BELZONA 3121 RELINES VALLEY GUTTER AT LARGE HOSPITAL

ID: 8689

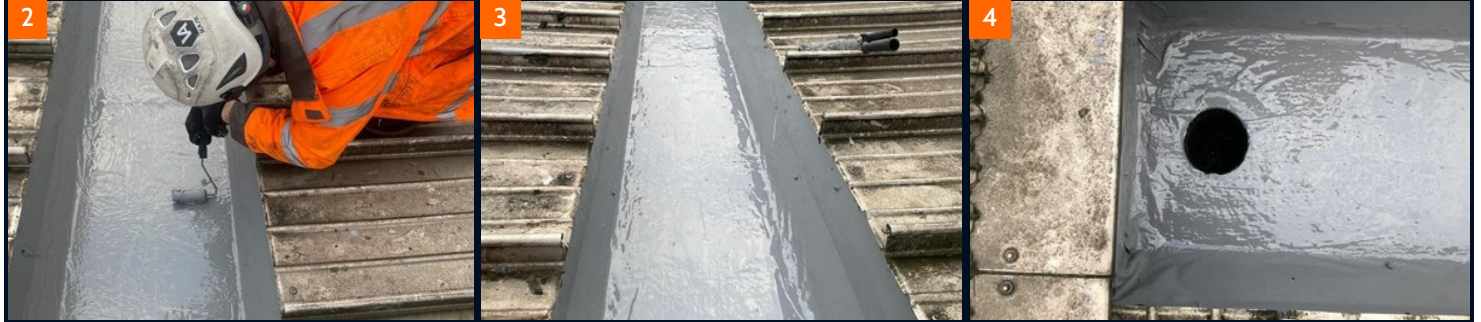
1. Before Application
2. During Application
3. After Application
4. Completed Gutter and Downpipe

All surfaces were prepared in line with the Belzona 3121 Instructions For Use. The first coat was applied to the prepared substrate along with Belzona 9331 reinforcing sheet, ensuring the fibrous side of the sheet was facing down. The product was overlapped on either side of the central run by approximately 0.5" (12.5mm). This was applied in accordance with Belzona System Leaflet RPA-06.
