# BELZONA REPAIRS AND PROTECTS FRANCIS TURBINE

ID: 8706

Restoration of a 91Mw francis turbine within an Hydroelectric power plant.

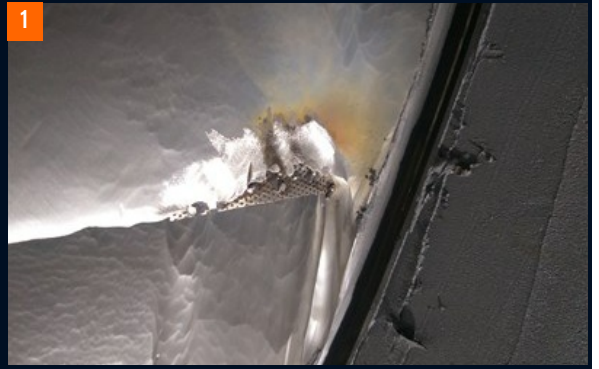
- 1.) Rebuilt damaged vanes with perforated sheet
- 2.) Cavitated vane tips repaired with Belzona 1311
- 3.) 1st coat of Belzona 1341
- 4.) Final application

This application was carried out in accordance with modified system leaflets CEP-01, CEP-05 & CEP-10.  
First, the turbine was grit blasted to SA2.5, achieving a surface profile of 75 microns before being cleaned with Belzona 9111. Once the surface was clean & dry, any severely pitted areas or damaged vanes were rebuilt with Belzona 1311 along with perforated metal sheets, restoring the turbine back to it's original dimensions. After the 1311 had cured, the surface was frost blasted (40 microns) before applying 2 coats of Belzona 1341. Finally Belzona 2941 conditoner and Belzona 2941 were applied to the the tips of the turbines vanes as these areas were most susceptible to cavitation.
