# BELZONA PROTECTS AGAINST CORROSION IN FAN SHROUD

ID: 8775

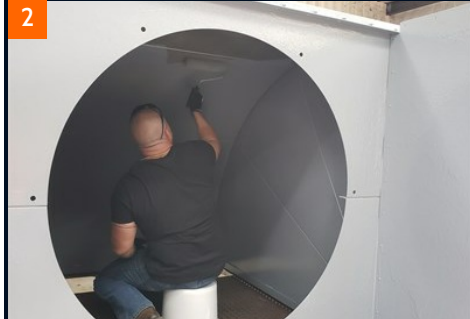
A brand new paper milling fan shroud picks up a lot of caustic mist, eventually corroding the inside of the shroud. A coating was then required to protect the shroud from the corrosion that would have eventually formed over time.

1. Fan shroud.
2. Fan shroud being coated.
3. Fan being coated
4. Coated pieces.

Preparation was done by a combination of abrasive blasting and MBX by hand to achieve a SP10 near white metal finish for a good mechanical adhesion. Belzona 5811 was then mixed and applied as two coats on the shroud.
