# BELZONA REPAIRS A LIVE WATER LEAK ON A REFRIGERANT SUCTION PUMP

ID: 8846

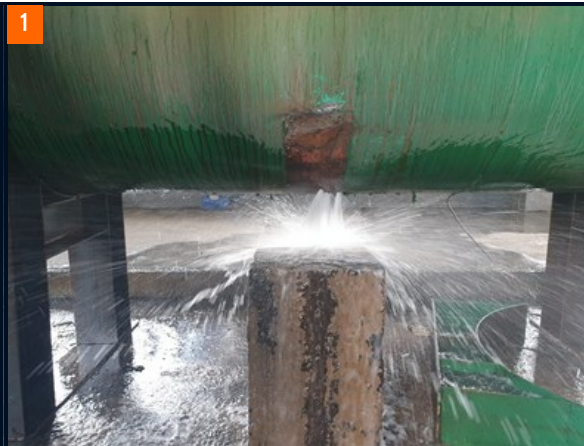
The pipeline connected to a suction pump on a closed circuit refrigeration system had suffered from bi-metallic corrosion (A.K.A galvanic corrosion) due to the pipe support, resulting in a complete loss of wall thickness at several locations, leading to live leaks needing to be repaired.

- 1). Leaking pipe once the support was removed.
- 2). Plate bond using Belzona 1212 and held in place using a strap during the polymerisation stage.
- 3). Belzona 5811 applied over the plate to prevent any future corrosion in the area.
- 4). Completed application, overcoated with Belzona 5811.
