# BELZONA PROTECTS NEW CHEMICAL CONTAINMENT AREAS AT REFINERY

ID: 89

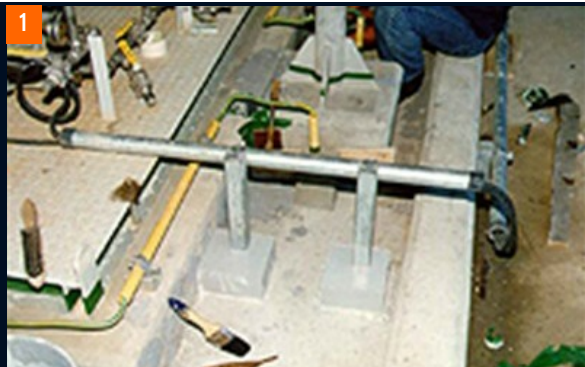
1. Electrical and pipe supports were grouted into place using Belzona 4111 system
2. Application of Belzona 4311 underway
3. & 4. Views of some of the many completed areas
