# BELZONA 1321 INVESTMENT COATING FOR PUMP PRESERVATION

ID: 8944

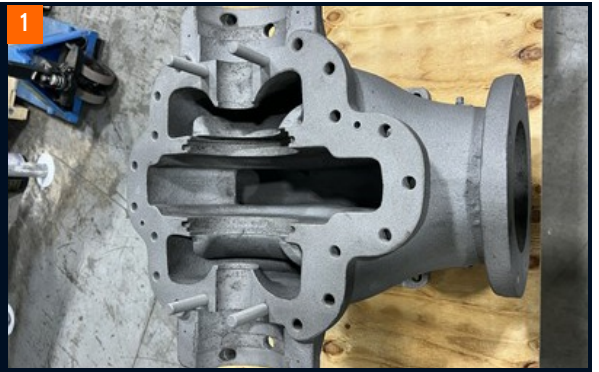
1. Pump after being sandblasted/prepared.
2. First coat of Belzona 1321 (grey).
3. Second Coat of Belzona 1321 (blue).
4. Second view of Belzona 1321's second coat.

After receiving the pump following sandblasting, we taped off the casing with duct tape to make a clean edge. We then applied one coat of Belzona 1321 (grey) using short bristled dog leg brushes and followed with a second coat of Belzona 1321 (blue) allowing appropriate cure times and finishes.
