# BELZONA 3211 PROTECTS LPG SPHERES

Pressurized storage spheres for Liquefied Petroleum Gas (LPG).

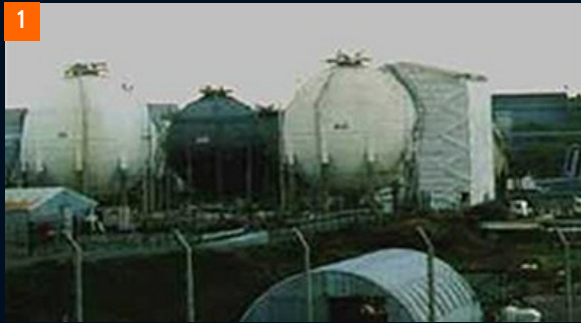
1

Water penetration through original insulation system had allowed severe underlagging corrosion to occur. The site is an exposed marine site and deluge systems on the sphere are regularly tested so that watertightness is imperative.

1. Work underway on one of the spheres within the environmental screen
2. Close up of the application showing complete sealing around pipework
3. A completed sphere

The insulation was re-installed using a closed cell foam glass that is impervious to water and Belzona® 3211 applied in accordance with Belzona Know-How Leaflet TCC-4.
