# BELZONA COLD-BONDED DOUBLER PLATES TO RESTORE HOLED DECK ON OFFSHORE PLATFORM

ID: 9019

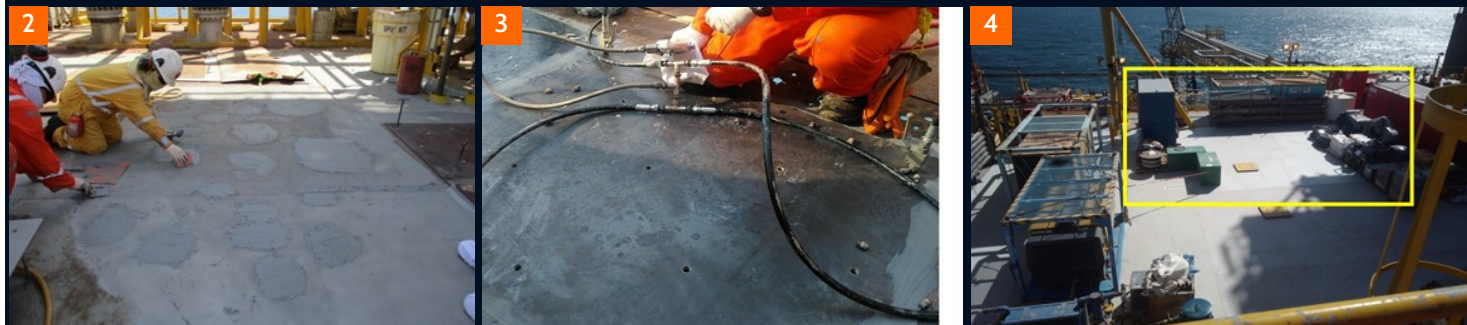
The client had problems with pitting and holes in the platform deck as a result of corrosion. This had resulted in an unsafe and insecure platform structures, which was hampering operations.

1. Holes in the surface plate of the deck due to severe corrosion
2. Holes were sealed and pitted areas were filled using Belzona 1111 and 1121
3. Inject Belzona 5811 to cold bond the doubler plate located
4. Once the bonding application of the doubler plates is completed, the deck top was coated with Belzona 5231 and 5233

Repair areas on the deck surface were cleaned and properly prepared. Holes, uneven areas, deep voids and pitting were sealed, filled and levelled using Belzona 1111 and 1121. Doubler plates were located in place, checking for level and alignment, and their edges and joints were sealed with Belzona 1121. Belzona 5811 was injected into the doubler plates to fill gaps and voids under the plates and provide adhesion and mechanical strength. The final finish was Belzona 5231 and 5233 (a UV resistant, anti-slip floor coating system) to protect the restored deck top from environmental degradation.
